Crossrail Lesson Review

Date:	16/05/2015	Time:	09:45	RIVO Incident No:	4398533
Contract Number:	C405	Location:	Paddington Station, Departures Rd		
Contractor & Subcontractor:	CSJV - Byrne Brothers				
Contact Name/Number:	Sarah Roche H&S Manager CSJV		Incident Type:	LTI	
Key Words:	Manual Handling/Lifting operations/Spill		Crossrail Ref:

Health and Safety Bulletin – Surface Transport

Cable Strike Incident

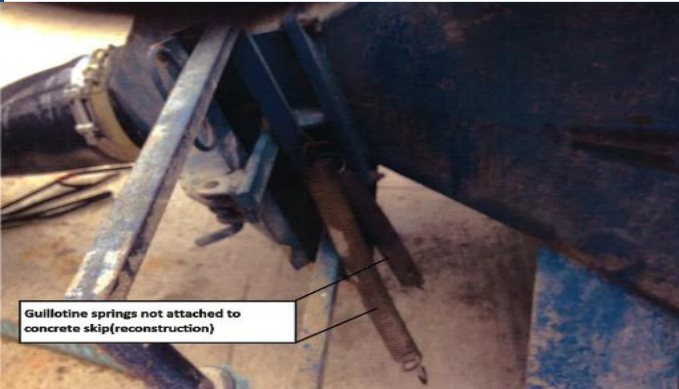
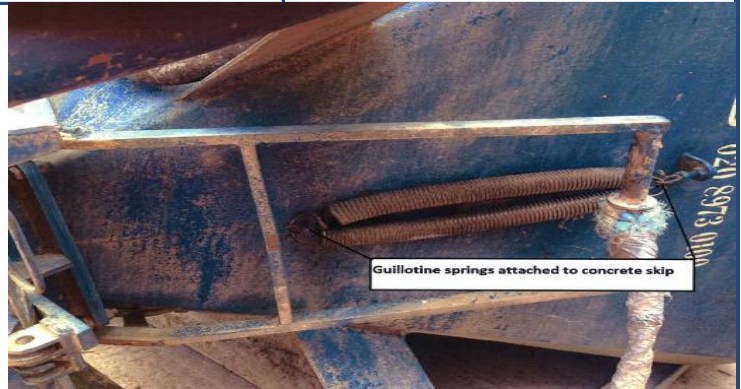
A crane supervisor was injured whilst attempting to clear up a concrete spill on the main site haul road. The spill occurred due to the guillotine springs not being reattached to the skip after being washed out by the concrete gang. A traffic marshal and crane supervisor used a shovel to shift the concrete from the road back into the skip. As the crane supervisor lifted his first load of concrete he felt a sharp pain his lower back. I.P. visited hospital and was given painkillers and anti-inflammatory medication. I.P. returned to work on 19.05.15 having lost 1 working day due to the sustained injury.

The crane supervisor (injured party) had noticed the springs were missing when he first carried out his pre-lift inspections, but as the skip was empty at this stage, he felt it was safe to proceed with the lift. The I.P was distracted by other lifting duties and did not reattach the springs prior to the skip being load with concrete.

- *Procedure* - During the washing out process on the concrete skips the guillotine springs were detached and not connected to the skip prior to being used for the next concrete delivery.

- *Rule-based mistake* - I.P. carried out a visual inspection of the skip and noticed the guillotine springs were missing, but as the skip was empty at this stage he felt it was okay to proceed with the lift and then attach the springs prior to the skip being loaded.
- *Skilled – based lapse*- After noticing the guillotine springs were missing he was distracted and forgot to attach the springs prior to the skip being loaded
- *Rule-based mistake* - After completing the washing out of the concrete skip the guillotine springs should have been reattached.

Project lifting team have been briefed on pre-lift visual checks of all lifting appliances and to ensure all is satisfactory prior to carrying any lifts.

The concrete gang has been briefed on the incident and told to ensure the guillotine springs are reattached after they have cleaned out the skips. The trade contractor will review their procedures to ensure this is made clear for future briefings.

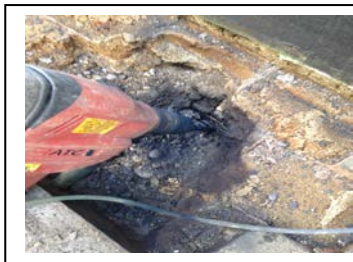
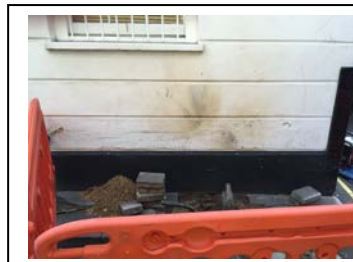
The works required the installation of signage and posts to reduce 'rat-running' through narrow side streets in the area as a consequence of lane reductions. During the installation of the second sign-post an operative came across a service that was encased and struck a cable. He suffered burns following electrical discharge. He was using mechanical tools. The emergency services arrived and took the injured party to hospital.

Initial findings identified additional activities were scheduled outside of the normal planning/programming process. The operatives were instructed to carry out the intrusive work by their supervisor and were not wearing flame retardant PPE, as specified in the Risk Assessment & Method Statement. Had the appropriate PPE been worn the IP's injuries may have been lessened.

The stats drawings and GPR surveys previously undertaken did not cover the location of this sign post installation, Though the area was CAT scanned, it was done without using the associated 'Genny', resulting in the 'live' cable going undetected. Further investigation also highlighted further issues regarding the confidence of the operatives in using this equipment.

Injured party received burns to both forearms (the more extensive being the outer left forearm), burns to the inner upper thigh (left leg) and burns to the face and neck.

- Adequate enquiries must be made into the location of sub-surface utilities including the acquisition of suitable STATS drawings and appropriate surveys – eg. BSI PAS 128, confidence level surveys, A, B, C,D.

- Only competent persons must undertake scanning of the area, using suitable, calibrated equipment, prior to any intrusive works taking place, marking any findings with spray paint or similar. Scanning may need to be repeated throughout the excavation process.
